PUCH M125 - SUMP COOLING FIN GAPS

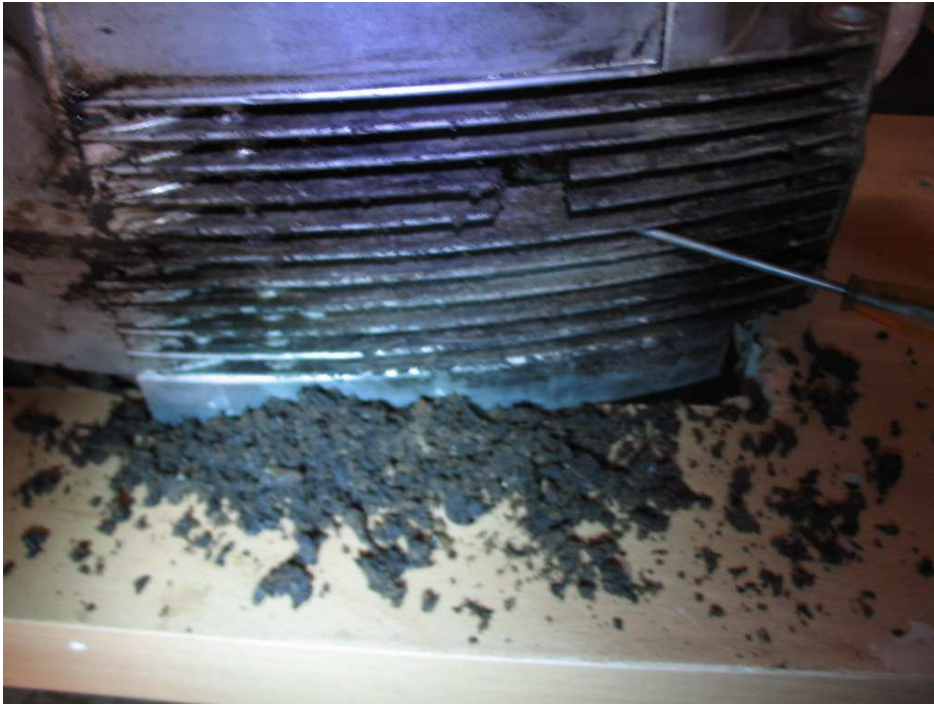
The photo shows just some of the mud and gunge that I removed with the aid of a screwdriver and a thin bladed knife. I then cleaned the fins with a paintbrush and petrol before drying them with a cloth.

The gaps are 40mm deep in one place and were almost completely full of muck.

Before I separated the crankcases to replace the crankshaft seals, and with the engine laid on its side, I cleaned out the sump cooling fin gaps.

It is difficult to clean the gaps with the engine in the frame, but worth doing to prevent the gearbox oil becoming too hot.
